## Lakefront Seawall Repair in Wisconsin

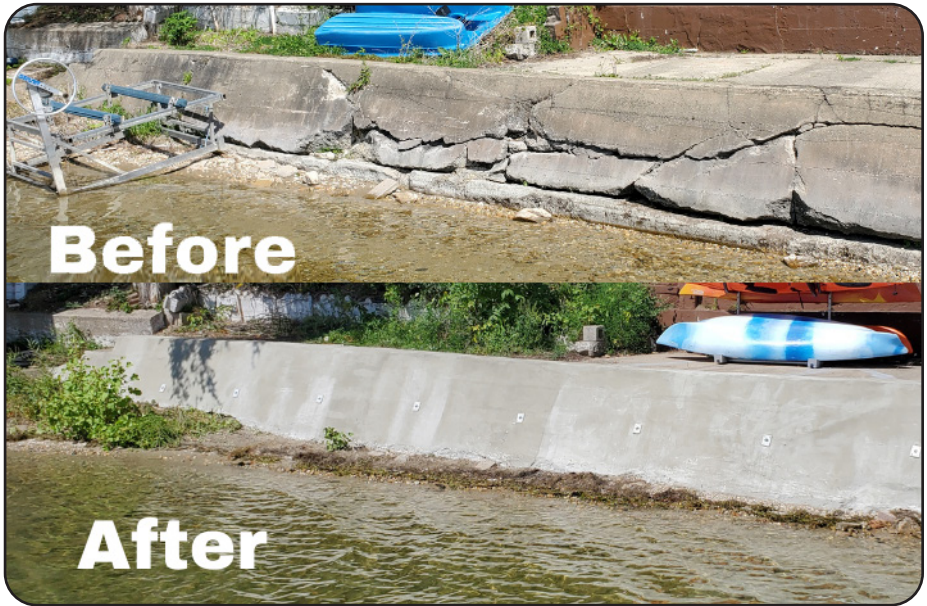
The owner of a marquee lakefront property near Genoa City, Wisconsin contacted Seawall Repair Network contractor Phase One Shoreline Solutions regarding their crumbling seawall. There was a 75-foot slope behind the wall, guiding rainwater down into the soil behind the structure. There was no drainage system in place, so the water in the soil created immense hydrostatic pressure over time. If the wall failed completely, the slope behind it would begin to erode into the lake, dramatically affecting the value of the property.

The dramatic before and after pictures included in this case study indicate the effectiveness of this repair job. The original strength and appearance of the wall were restored. Safeguards were put into place to alleviate the cause of degradation, thus preventing future damage. The customer emailed the contractor with a simple three-word response to this repair job: "I love it!"

The crew began by injecting the high-strength SW-RP1 repair material into the soil behind the wall in order to provide structural support and stop water leaks. Next, they repaired the cracks in the wall with high-performance patching concrete. After that, they installed pressure release technology in order to prevent future hydrostatic pressure build-up. Finally, they coated the entire wall with waterproofing cementitious coating.
