## Repairing a Wooden Seawall in Florida

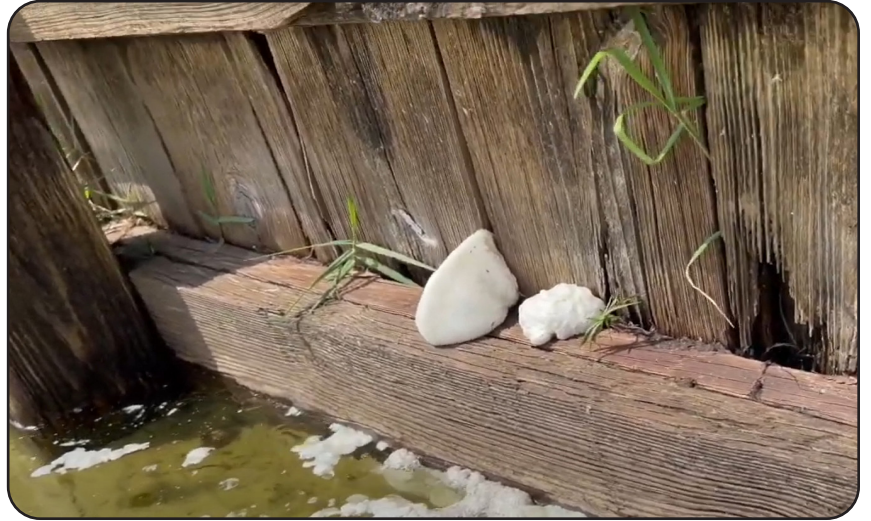
Residents next to Lake Padgett in Land o' Lakes, Florida contacted Seawall Repair Network contractor Helicon regarding 650 feet of leaking wooden seawall. Depressions were appearing in the land behind the wall, holes were appearing in the wall, and soil was leaking through the wall into the lake. Initially, the residents just had the soil voids and depressions filled with more dirt. This solution didn't last long, however, as the new soil eventually leaked through the wall and the depressions reappeared. If left untreated, this problem would have continued to erode the lakeside property and would have eventually become a threat to houses and structures near the water.

The crew applied the Seawall Repair Network's proprietary SW-RP1 repair material to stabilize the surrounding soil, fill the holes and voids, and stop the leaks.

Helicon used Seawall Repair Network's patent-pending process and installation techniques to completely stabilize the wooden seawall and preserve its components. A barrier was installed to prevent the environmentally-friendly foam from floating out into the lake and all excess material was removed.

The entire 650-foot stretch of failing seawall was stabilized and sealed for the long term with high-strength SW-RP1 seawall repair material.
