Seawall Repair in Carrollton, GA

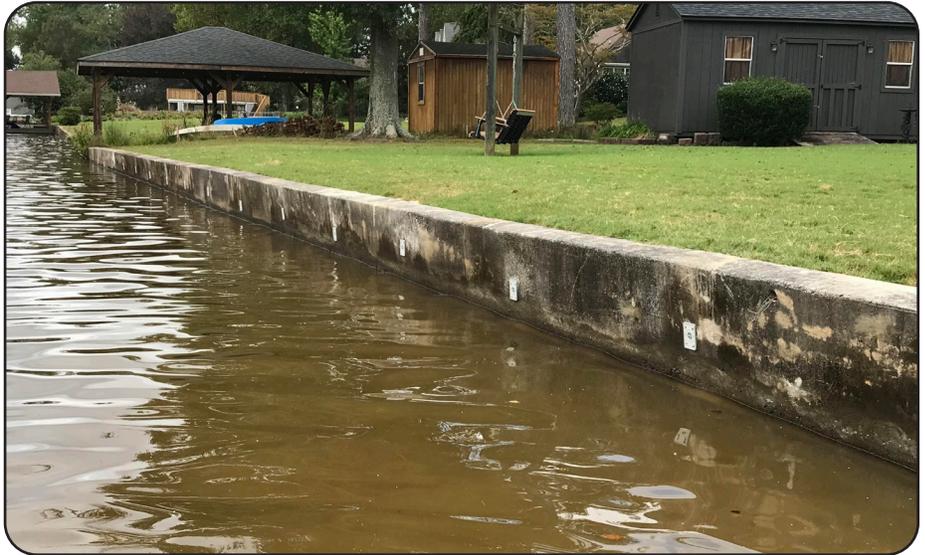
A homeowner on a private lake in Carrollton, Georgia contacted Seawall Repair Network® looking for a way to save their failing seawall. A representative from member contractor Ground Consolidation Solutions promptly arrived to perform a free assessment. There was significant soil loss on the land side. In addition, the seawall itself was starting to shift due to a buildup of hydrostatic pressure.

Given that there were two separate issues occurring, a two-pronged repair approach was in order. First, the crew backfilled the soil voids with coarse river sand, then they injected SW-RP1 repair material from the bottom of the seawall up to the top. This ensured that all of the leaks were sealed off. In addition, the SW-RP1 resin permeated the soil, creating a solid mass to add structural support. Next, the crew addressed the hydrostatic pressure issue. Hydrostatic pressure occurs when groundwater on the soil side builds up and has nowhere to escape, putting undue pressure on the seawall. To alleviate this pressure, the crew installed panel filters every 6 feet, along the face of the seawall just above the average water line. The filters allow water to pass through from the landside without any soil loss.
