## Seawall Repair in Greensboro, GA

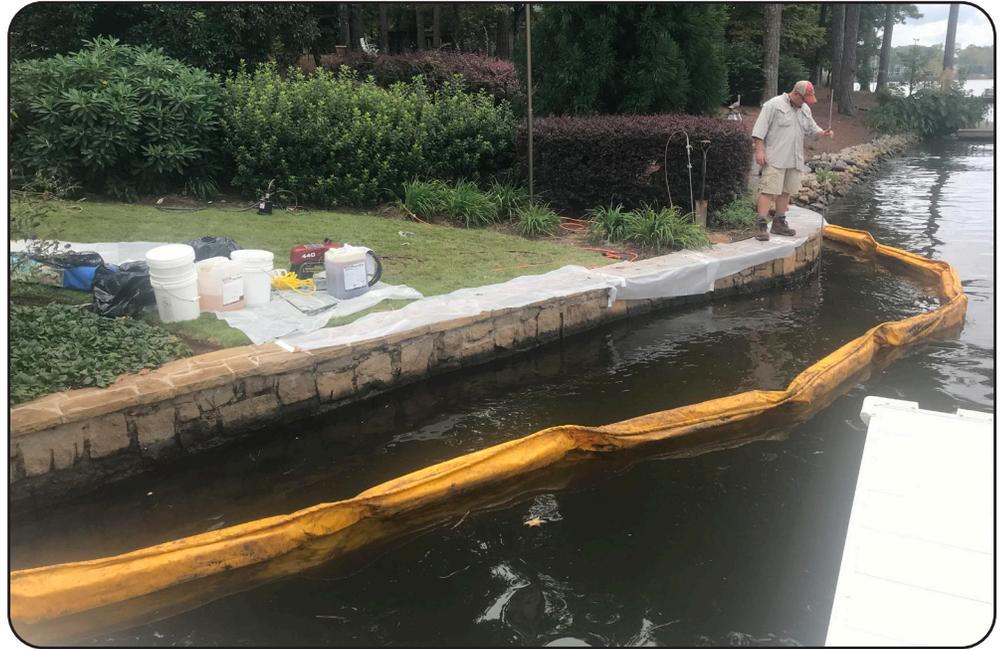
A homeowner on Lake Oconee (located in Greensboro, Georgia) contacted the Seawall Repair Network® looking for a solution to the soil loss issue occurring behind their seawall. A crew from member contractor Ground Consolidation Services promptly arrived to perform a free assessment. The problem was quickly diagnosed and a repair plan was devised on the spot. Even though seawalls on lakes aren't subject to the tidal action that coastal

structures are, wakes from boat and jet ski activity cause the same erosion and soil loss issues. This particular seawall was in great shape and the backyard leading down to it was pristine, however, soil loss on the land side of the seawall was putting that situation in jeopardy. When the homeowner learned that the soil issue could be remedied with no excavation, his next question was, “when can you start?”

The crew began by backfilling the void areas with coarse river sand. They then injected SW-RP1 from the toe of the seawall up to the surface. They sealed off all the areas where the soil was being lost under the seawall and permeated the sand on the land side, creating a solid soil mass. As a precaution, they placed a turbidity barrier in the water to catch excess cured repair material, which is NSF approved for contact with potable water.
