Seawall Repair – Lake of the Ozarks, Missouri

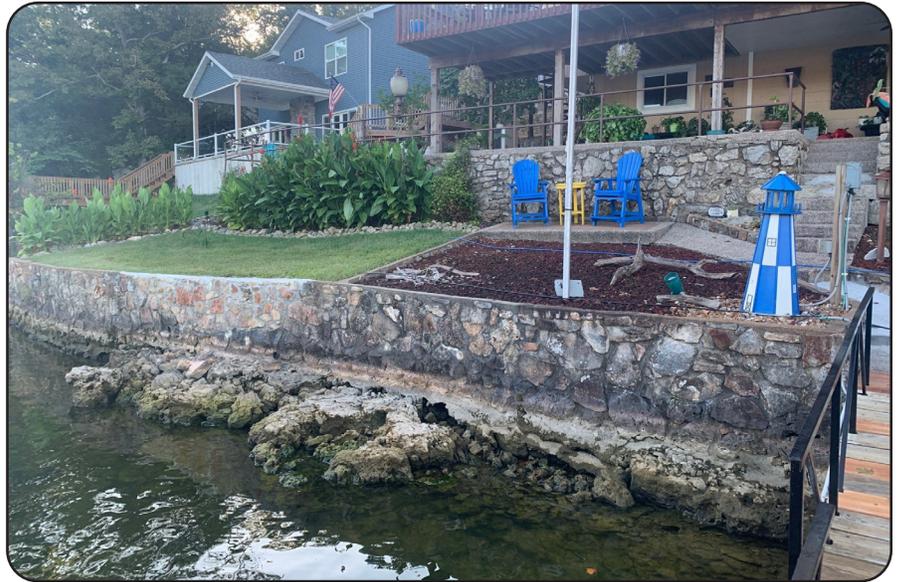
A homeowner on the Lake of the Ozarks in Missouri reached out to Seawall Repair Network® member contractor RT Construction after noticing soil erosion behind their seawall. This particular seawall was constructed with stacked stones that had been mortared together. Over the years, some of the stones broke loose and fell out, leaving gaps in the wall. Water poured through these gaps and eroded soil on the landward side of the wall, creating large voids behind the structure. In addition, the old drainage system that had been installed with the wall in order to prevent water buildup on the landward side was no longer working.

On the landward side of the wall, the crew began by inserting a half-inch injection rod to a depth of about 1 foot below the mud line (the point at which the bottom of the lake intersects with the seawall). SW-RP1 was then injected, the rod raised a little, more material was injected, and so on until that area behind the seawall was stabilized. This process was repeated every few feet along the back of the wall until the entire 100 foot seawall was reinforced and sealed up. Next, the crew installed panel filters between each injection location, allowing for water drainage into the lake and preventing any future damage from hydrostatic pressure.
