Lakefront Seawall Repair in Wisconsin

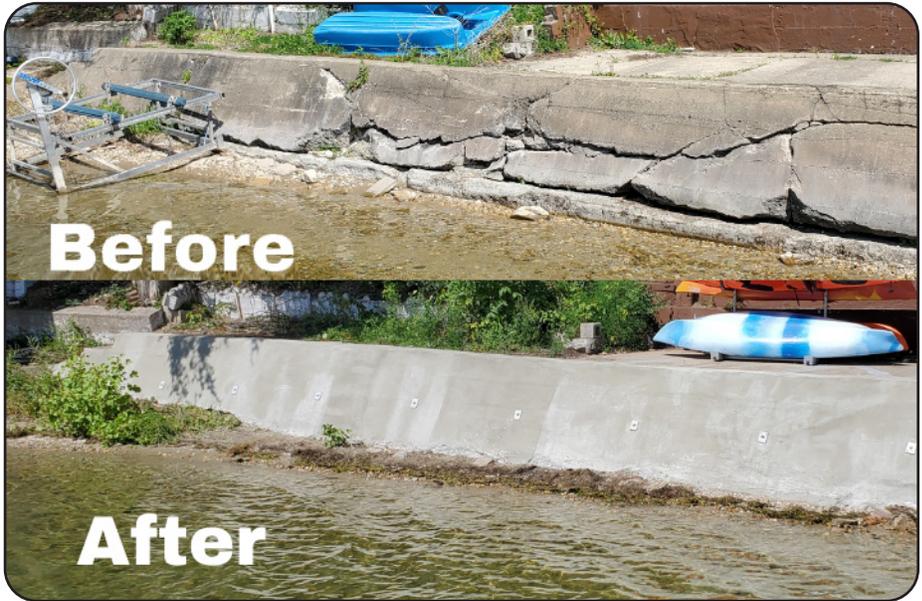
The owner of a marquee lakefront property near Genoa City, Wisconsin contacted Seawall Repair Network® contractor Phase One Shoreline Solutions regarding their crumbling seawall. There was a 75-foot slope behind the wall, guiding rainwater down into the soil behind the structure. There was no drainage system in place, so the water in the soil created immense hydrostatic pressure over time. If the wall failed completely, the slope behind it would begin to erode into the lake, dramatically affecting the value of the property.

The crew began by injecting the high-strength SW-RP1 repair material into the soil behind the wall in order to provide structural support and stop water leaks. Next, they repaired the cracks in the wall with high-performance patching concrete. After that, they installed pressure release technology in order to prevent future hydrostatic pressure build-up. Finally, they coated the entire wall with waterproofing cementitious coating.
