Repairing a Wooden Seawall in Florida

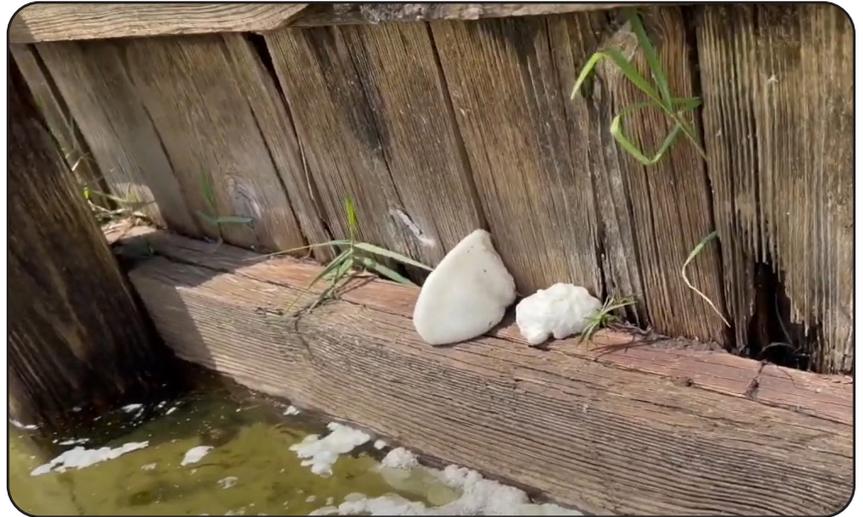
Residents next to Lake Padgett in Land o' Lakes, Florida contacted Seawall Repair Network® contractor Helicon regarding 650 feet of leaking wooden seawall. Depressions were appearing in the land behind the wall, holes were appearing in the wall, and soil was leaking through the wall into the lake. Initially, the residents just had the soil voids and depressions filled with more dirt. This solution didn't last long, however, as the new soil eventually leaked through the wall and the depressions reappeared. If left untreated, this problem would have continued to erode the lakeside property and would have eventually become a threat to houses and structures near the water.

The crew applied the Seawall Repair Network®'s proprietary SW-RP1 repair material to stabilize the surrounding soil, fill the holes and voids, and stop the leaks.

Helicon used Seawall Repair Network®'s patent-pending process and installation techniques to completely stabilize the wooden seawall and preserve its components. A barrier was installed to prevent the environmentally-friendly foam from floating out into the lake and all excess material was removed.

The entire 650-foot stretch of failing seawall was stabilized and sealed for the long term with high-strength SW-RP1 seawall repair material.
