## Repairing an Aging Seawall in New York

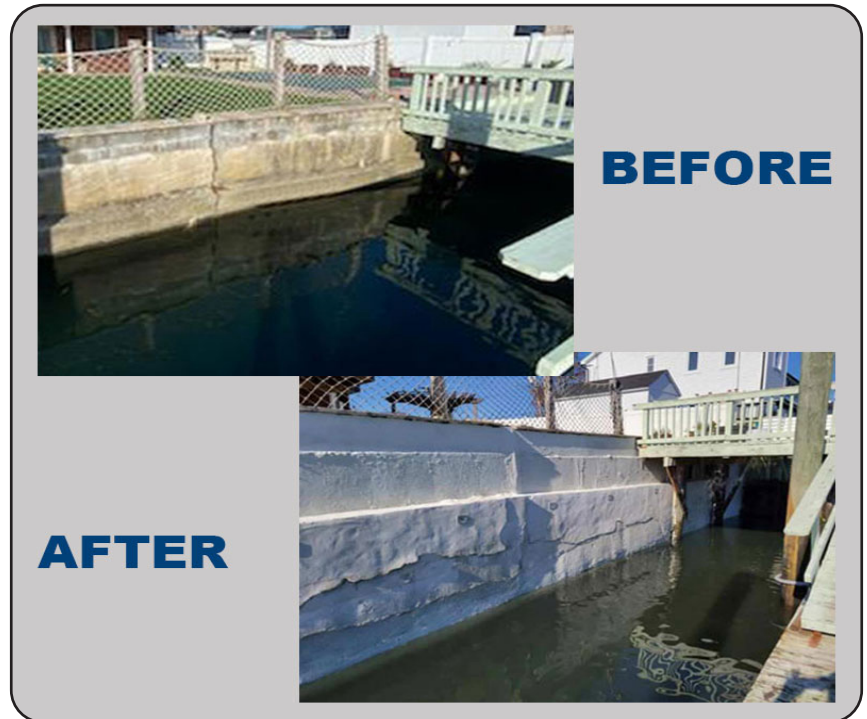
Hurricane Sandy was devastating for much of the Northeast United States. Many waterfront property owners are still recovering, and their seawalls, bulkheads, and revetments are still in need of repair and remediation. The need for innovation and effective solutions has never been greater. Seawall Repair Network® contractor LJS Waterproofing answered the call recently and deployed to Long Beach, New York to save a waterfront property from further damage. The Long Beach property was in danger due to an aging seawall that had begun to move, shift, and become damaged.

The crew applied the Seawall Repair Network®'s proprietary SW-RP1 repair material to stabilize the surrounding soil and stop the leaks.

The LJS crew used Seawall Repair Network®'s patent-pending process and installation techniques to completely stabilize the seawall, and to preserve its concrete and steel components.
