Stabilizing and Preserving a Lakehouse Seawall in Michigan

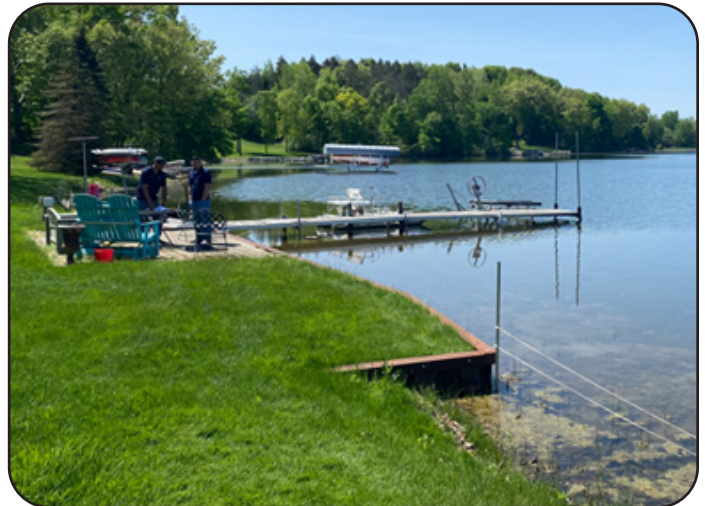
SRN member-contractor Bluebird CFW of Michigan was recently called to assess a residential lakeside steel sheet pile seawall. The homeowner noticed that the seawall was beginning to lean slightly, and the soil around the base of the wall was washing away. Concerned about the stability of the seawall and the potential for property loss, the homeowner contacted Troy and his team for help.

Upon arriving at the site, Troy began to assess the situation. They examined the seawall and the surrounding soil, looking for signs of instability or erosion. They also performed soil probing tests to determine the cause of the problem. After completing their assessment, Troy and his team determined that the seawall was experiencing soil loss due to a combination of factors, including the presence of underground water and the weight of the soil on the seawall. To stabilize the seawall and prevent further soil migration, they decided to utilize the Seawall Repair Network®'s SW-RP1 installation method, which involves the creation of dewatering channels to remove excess water from the soil. Over the course of several days, Troy and his team worked to stabilize the seawall and prevent further soil migration. They monitored the dewatering channels closely, adjusting the flow of water as needed to maintain the stability of the seawall.
