## Lakefront Seawall Repair in Wisconsin

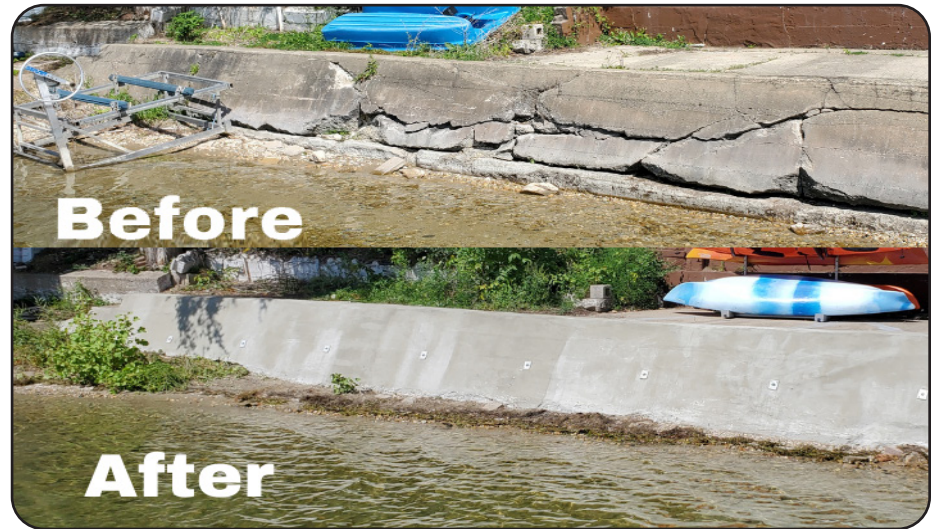
The owner of a marquee lakefront property near Genoa City, Wisconsin contacted Seawall Repair Network contractor Phase One Shoreline Solutions regarding their crumbling seawall. There was a 75-foot slope behind the wall, guiding rainwater down into the soil behind the structure. There was no drainage system in place, so the water in the soil created immense hydrostatic pressure over time. If the wall failed completely, the slope behind it would begin to erode into the lake, dramatically affecting the value of the property.

The crew began by injecting the high-strength SW-RP1 repair material into the soil behind the wall in order to provide structural support and stop water leaks. Next, they repaired the cracks in the wall with high-performance patching concrete. After that, they installed pressure release technology in order to prevent future hydrostatic pressure build-up. Finally, they coated the entire wall with waterproofing cementitious coating.

The dramatic before and after pictures included in this case study indicate the effectiveness of this repair job. The original strength and appearance of the wall were restored. Safeguards were put into place to alleviate the cause of degradation, thus preventing future damage. The customer emailed the contractor with a simple three-word response to this repair job: "I love it!"
