Repairing a Wooden Seawall in Florida

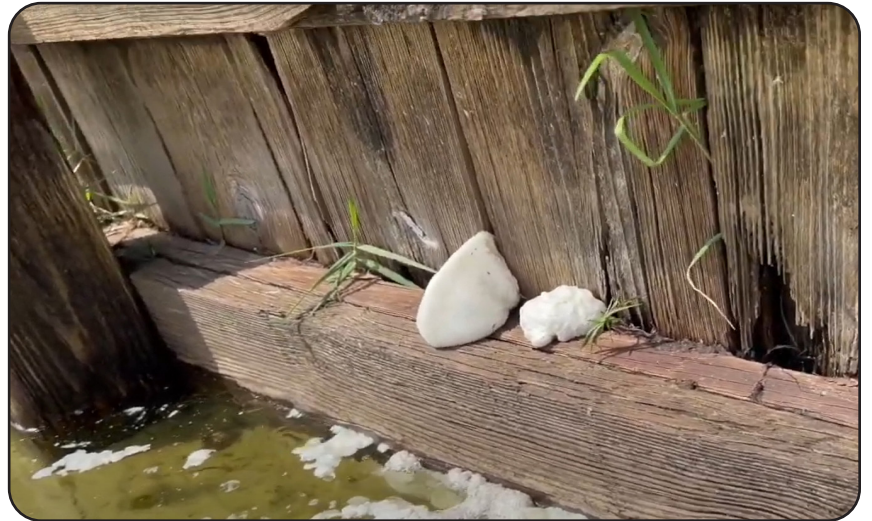
Residents next to Lake Padgett in Land o' Lakes, Florida contacted Seawall Repair Network contractor Helicon regarding 650 feet of leaking wooden seawall. Depressions were appearing in the land behind the wall, holes were appearing in the wall, and soil was leaking through the wall into the lake. Initially, the residents just had the soil voids and depressions filled with more dirt. This solution didn't last long, however, as the new soil eventually leaked through the wall and the depressions reappeared. If left untreated, this problem would have continued to erode the lakeside property and would have eventually become a threat to houses and structures near the water.

If left untreated, this problem would have continued to erode the lakeside property and would have eventually become a threat to houses and structures near the water.

The crew applied the Seawall Repair Network's proprietary SW-RP1 repair material to stabilize the surrounding soil, fill the holes and voids, and stop the leaks.

Helicon used Seawall Repair Network's patent-pending process and installation techniques to completely stabilize the wooden seawall and preserve its components. A barrier was installed to prevent the environmentally-friendly foam from floating out into the lake and all excess material was removed.

The entire 650-foot stretch of failing seawall was stabilized and sealed for the long term with high-strength SW-RP1 seawall repair material.
