Stabilizing and Preserving a Seawall in Portland, Maine

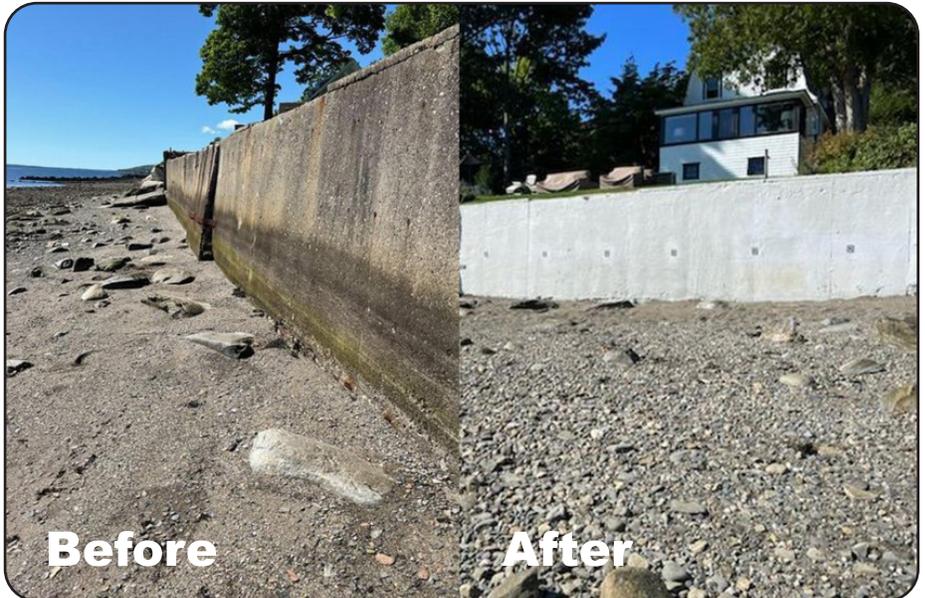
A waterfront property in Portland, Maine was in need of a seawall repair to protect the property from erosion and storm damage. This seawall showed signs of failure, including soil depressions near the wall, rust stains on the surface, movement and shifting, and cracks in the concrete. Seawall Repair Network® member LJS Waterproofing was called for an evaluation and advised that the property owner needed a solution that would both stabilize the seawall and preserve it for the long term.

The first step was to stabilize the soil and control hydrostatic pressure. This was done by injecting the Seawall Repair Network®'s SW-RP1 into the soil behind the seawall. SW-RP1 is a soil-stabilizing material that is stronger than crystalline bedrock and safe for the environment. It seals leaks and controls hydrostatic pressure, which helps to prevent further movement and shifting of the seawall.

The next step was to preserve the concrete seawall. This was done by applying the Seawall Repair Network®'s SW-Power to the surface of the concrete. SW-Power is a concrete hardener that strengthens the surface and makes it resistant to air or water-borne chemical damage. After that, LJS Waterproofing applied SW-Surcoat on top of the surface which is a concrete sealer that protects the surface of the seawall from water penetration, making it look nearly new.
