## Reservoir Seawall Repair in Jackson, Mississippi

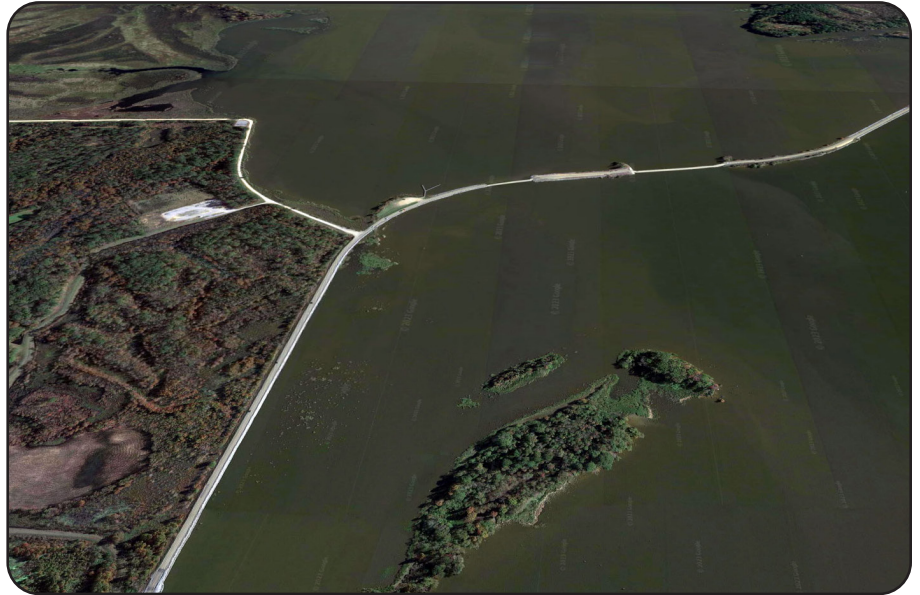
Engineers for the Pearl River Valley Water Supply District recently asked Seawall Repair Network® contractor Foremost Foundation & Construction to assess a seawall at the Ross Barnett Reservoir in Jackson, Mississippi, for repair work. Upon inspection, it was discovered that the seawall was losing soil and the seawall cap was sinking. This presented a significant risk to the stability of the seawall and the safety of those who use the reservoir for recreational purposes.

The technicians used SW-RP1 seawall repair material on this job. SW-RP1 transforms the surrounding soil into a water-tight impermeable mass, which blocks the transference of energy and lateral stress caused by the typical build-up of hydrostatic pressure behind the seawall. SW-RP1 is environmentally safe and is certified to NSF/ANSI/CAN 61 standards for contact with drinking water.

To address the issue, plans were developed to utilize the Seawall Repair Network® proprietary repair process. This procedure also prevents further erosion and deterioration. This is especially important at the Ross Barnett Reservoir, where the seawall is subjected to the harsh conditions of the marine environment on a daily basis. First the crew injections the repair material into the ground on the landward side of the wall. This process stabilizes the soil and seals leaks at the same time. Next, they install pressure control valves, which release any future water build-up behind the wall back into the reservoir in a controlled manner, preventing damage to the wall from hydrostatic pressure. Finally, any remaining cracks on the surface of the wall are repaired with high-strength epoxy.

The seawall repair project was a success. The seawall was stabilized, and the soil behind it was protected from further movement and shifting. The client was pleased with the results.
