Case Study

Protecting Drinking Water from Potential Flood Contamination in Washington, D.C.

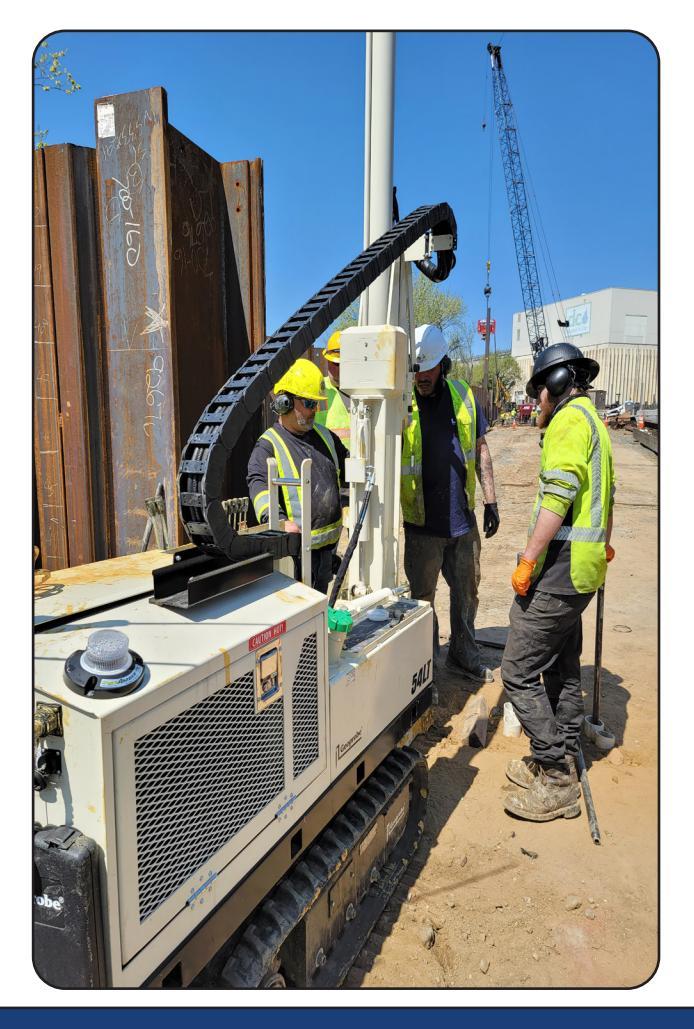
LJS Waterproofing professionals used a Geoprobe to drive injection pipes into the ground (up to 33 feet in some locations). They then injected one gallon per foot using upward staging. The next injection point was 18 inches away from the first one. This process was repeated until a grout wall formed, filling the gap between the two adjacent underground sheet piles. For a large-scale job like this, they used a PolyShark single component grout pump manufactured by Alchemy-Spetec.

The crew "constructed" these sections of the underground wall by injecting SW-RP1. This repair material permeates the soil, fills small voids in the soil, and cuts off water flow.

With solid, impermeable grout walls filling in the gaps, a sub-surface barrier between the riverbank and the drinking water facility was now in place. The planners at D.C. Water were very satisfied with this solution.
