Bulkhead Repair at the Miami Seaquarium

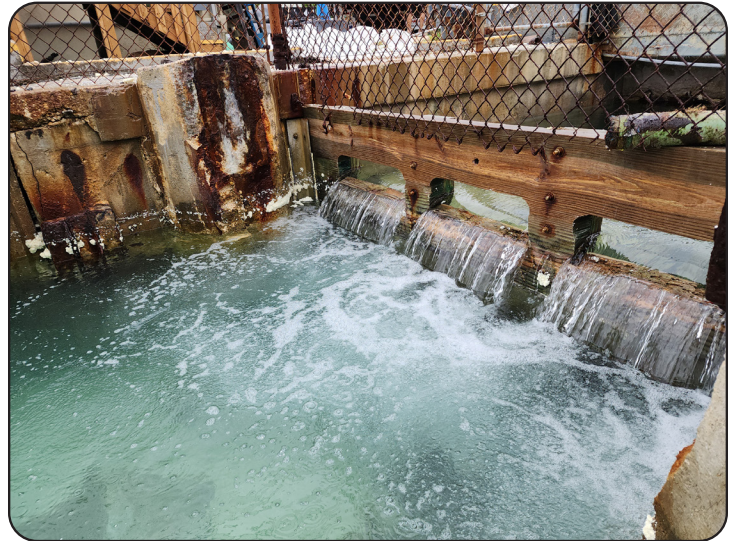
The Miami Seaquarium called on Seawall Repair Network® member contractor Atlas Seawall Solutions to evaluate a unique issue that had developed inside their park after the last hurricane. The park uses seawater that's constantly pumped in from the ocean to fill all the tanks and aquariums to a very precise level, then the water is released through overflow spillways into the main discharge bulkhead, which then releases the water back into the ocean. The main discharge bulkhead works as a spillway, allowing the water to reach a certain height and then spill over the top. During the last hurricane event, the bulkhead became damaged and a 2' x 3' hole formed underneath the structure, allowing an enormous amount of water to escape from under the bulkhead rather than spilling over the top. This caused a big problem for the aquarium. With this much water escaping from under the bulkhead, the inlet pumps were not able to keep up and the water level inside the park dropped dramatically. This forced the grounds crew to run backup pumps to supply the park with more water.

Once on-site, the crew began by trying to slow the leak by filling the 2'x3' hole with 20 lbs of oil-free Oakum. After the leak was slowed, they immediately started to introduce SW-RP1 into the oakum-filled hole in the bottom of the bulkhead. The SW-RP1 was catalyzed to the highest rate allowable due to the amount of flow that was still present even after filling with oakum.

After 30 minutes and 35 gallons of SW-RP1, Atlas Seawall Solutions had the leak completely stopped. The leak flow rate before the repair was estimated at 5,434 GPM. The leak flow rate after the repair was estimated at 0 GPM. The total end-to-end completion time from the arrival of the technicians until the total leak flow stoppage was only 5 hours.
