**SEAWALL
REPAIR NETWORK**

Case Study

Repairing a Marina Seawall in Venice, Florida

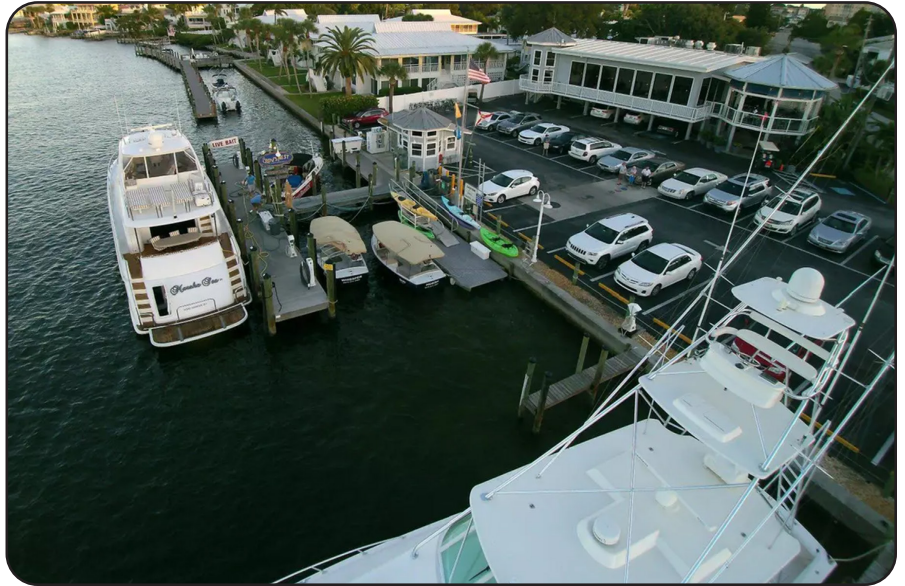
Soil depressions behind 655 linear feet of marina seawall, settling walkways, voids in asphalt roadways, cracking concrete, sinking boat cranes, and premature failure of infrastructure are just a few things that the Crows Nest Marina in Venice, Florida reached out to us for help with. Helicon (of Tampa Bay/Saint Petersburg, Florida) is a Seawall Repair Network preferred marine contractor. They were called to the marina and immediately performed a comprehensive seawall assessment and overall geotechnical evaluation. Helicon's crew examined all of the damage caused by soil erosion, soil migration, soil sheering, and void formations related to the seawall.

The technicians identified the aging seawall as the root cause of most of the damage. Specifically, the seawall was allowing soil on the landward side to migrate into the water through defects in the structure. Subsequent soil instability on the landward side then caused damage to ancillary structures (i.e., roadways, concrete, boat cranes, and some of the buildings).

The crew repaired the structure with Seawall Repair Network's proprietary repair material SW-RP1. This high-strength resin is environmentally friendly and ideal for filling voids, stopping leaks, and stabilizing the supporting soil around seawalls.

Helicon technicians executed Seawall Repair Network's proprietary seawall stabilization process to restore strength and integrity to the structure. Once the seawall was permanently stabilized and sealed to prevent further soil erosion, the Helicon team then addressed the remainder of the marina's infrastructure repair needs (i.e., slab lifting, void filling under slabs, etc).
